# Manhole Inspection Summary

Manhole # S09WW\_014MH

Insp Date: **4/10/07 10:54 AM**

**Location** Address: **3504 CEDARDALE RD**

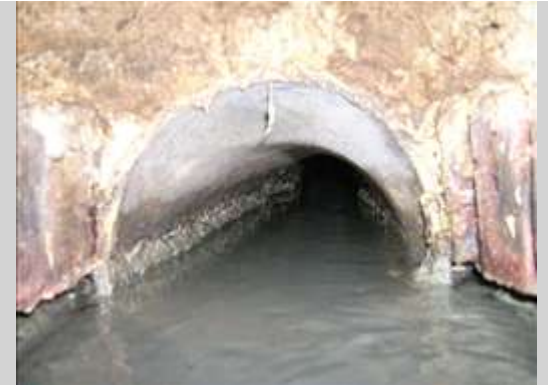
12 O'Clock Outflow

8 in. Circular Gravity Sewer  
Pipe Out @ 12 O'Clock

Pipe Height: (in.) Direct  
Pipe Material: **PVC** ☐ Pipe Lined  
Invert Depth: **6.10** (ft.) Flow Characteristics: **Slow**  
Deposits: ☒ None ☐ Mud ☐ Sludge ☐ Debris ☐ Grease  
Silt Depth: (in.) Deposits Extent:  
Infiltration: **None** Pipe Seal Cond: **Sound**

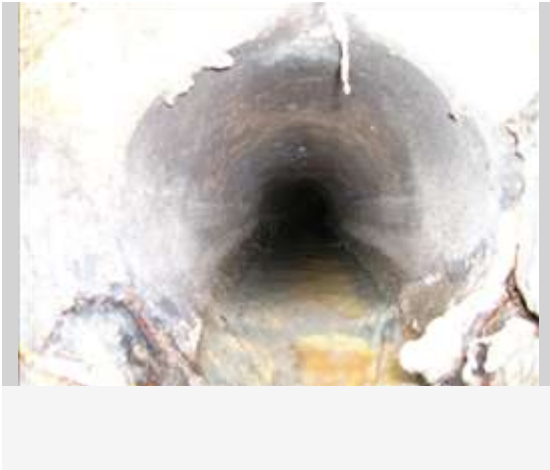
9 O'Clock Inflow

8 in. Circular Gravity Sewer

Pipe In @ 9 O'Clock

Pipe Material: **PVC** ☐ Pipe Lined

Infiltration: **None** Pipe Seal Cond: **Sound**
